**Coal Combustion Waste Impoundment
Round 5 - Dam Assessment Report**

Winyah Generating Station (Site #004)

**Santee Cooper
Georgetown, South Carolina**

Under Contract Number: EP-09W001727
January 2011

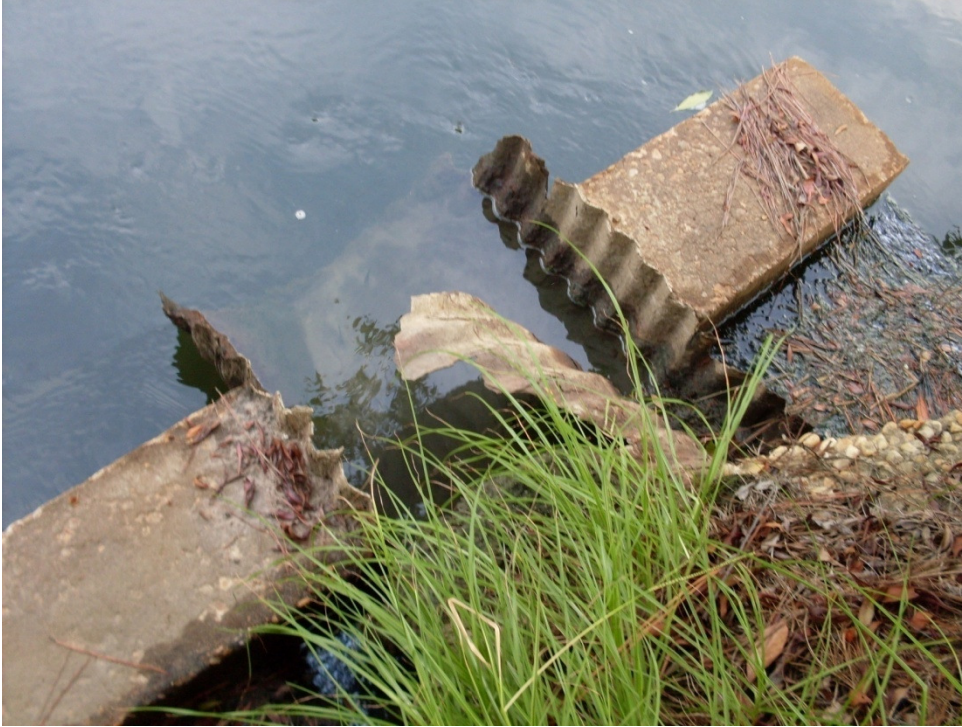
Depressions (“dropouts”) along the abandoned discharge pipe of Ash Pond A through the perimeter dam were observed. The depressions are possibly associated with structural failure of the pipe due to corrosion of a CMP section of the abandoned discharge pipe between the toe of the dam and the Discharge Canal

Photo BA-17: Failed CMP Outfall of Abandoned Decant Tower Drain Through West Dike of Ash Pond A – Viewed at Discharge Canal.

and/or due to joint separations. (It is not known if the CMP section continues through the perimeter dike to the intake riser.) Depressions with some exposed gravel along the Ash Pond B discharge pipe (RCP) through the perimeter dam were observed in the section between the toe of the dam and the Discharge Canal. The depressions were observed to be due to loss of overburden soil into separations at joints in the discharge pipe. As previously noted in Subsection 1.1.1, Santee Cooper should investigate both of these penetrations and implement appropriate remedial actions, as needed.

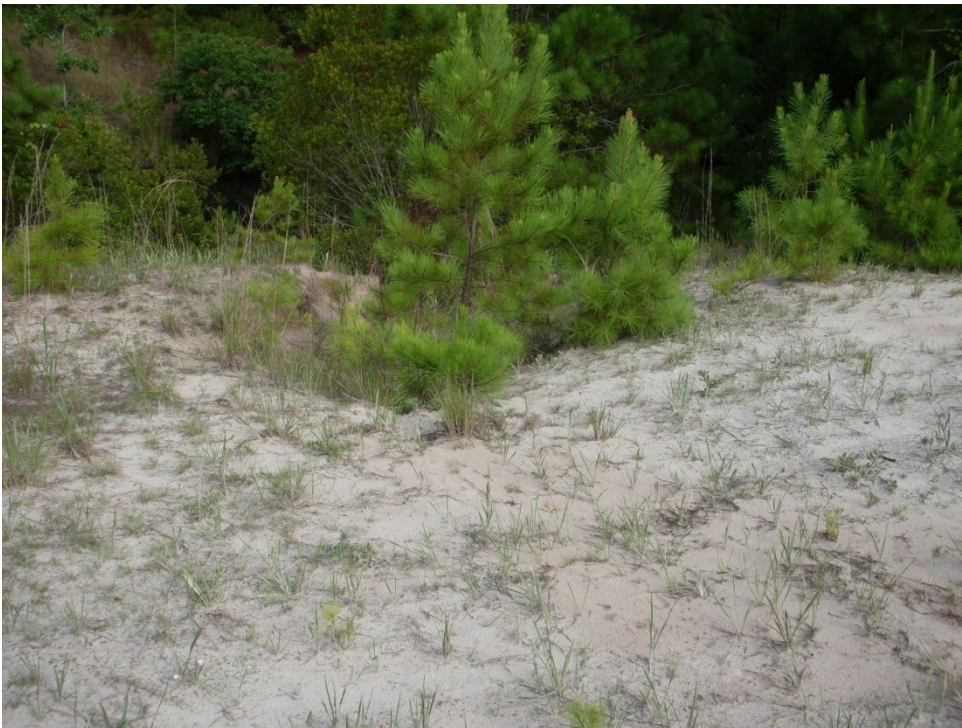
Photo BA-18: Depression in Ground Along Centerline of Failed CMP Outfall of Abandoned Decant Tower Drain Through West Dike of Ash Pond A.

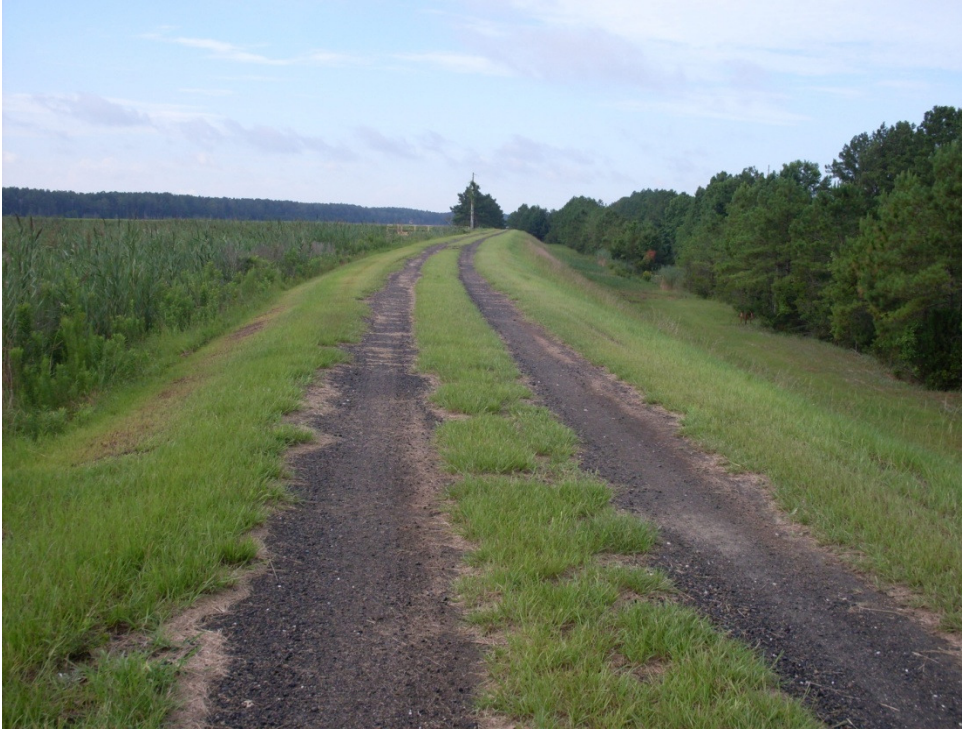
Photo BB-1: Crest of Perimeter Dike at Cross Dike Intersection – Viewed South.

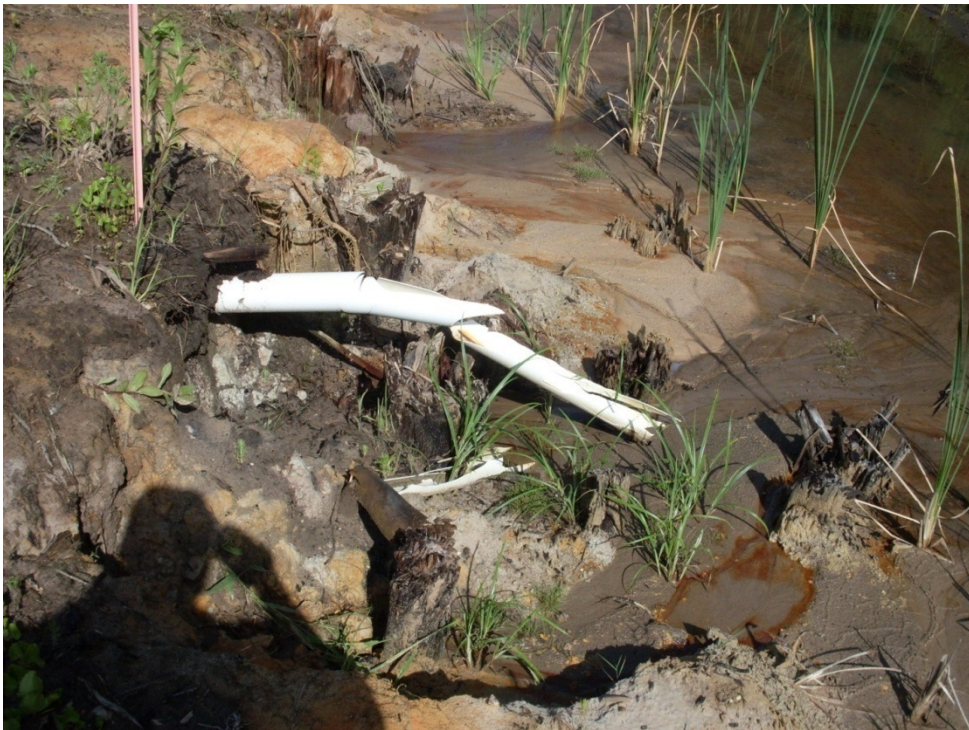
Photo BS-17: Damaged End of Toe Drain PVC Pipe Outlet at Toe Ditch Exposed by Erosion – Viewed East.

Some areas of poor grass cover were noted, particularly in toe areas where recent work on the toe drain outlets had been conducted. These areas should be reseeded as part of routine maintenance or otherwise protected with an inverted filter in the wet toe areas if grass cannot be established and maintained.

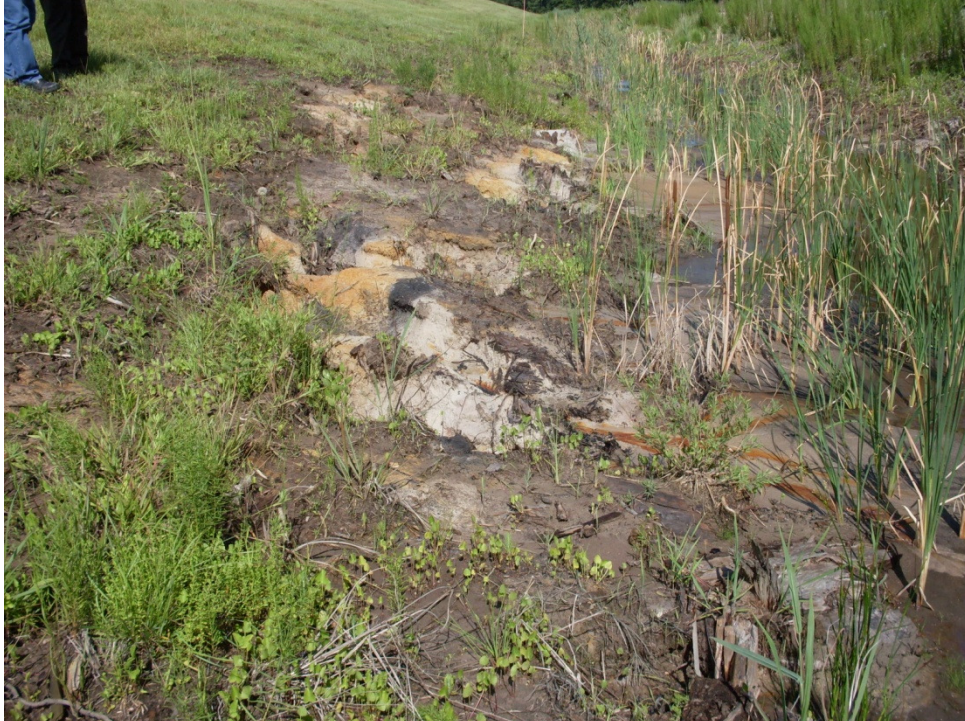
Wet soils and small seeps were observed along the outside toe of the embankment and at the toe drains; the wetness and small seeps appear to be associated with drainage of water collected in the toe drain and gradual seepage through the generally sandy foundation soils. These conditions do not threaten the stability of the perimeter dam at this time but should be visually monitored during routine inspections for any change in condition.

Photo BS-18: Wet Ground and Seepage Along Outside Toe Ditch South Side of South Ash Pond.

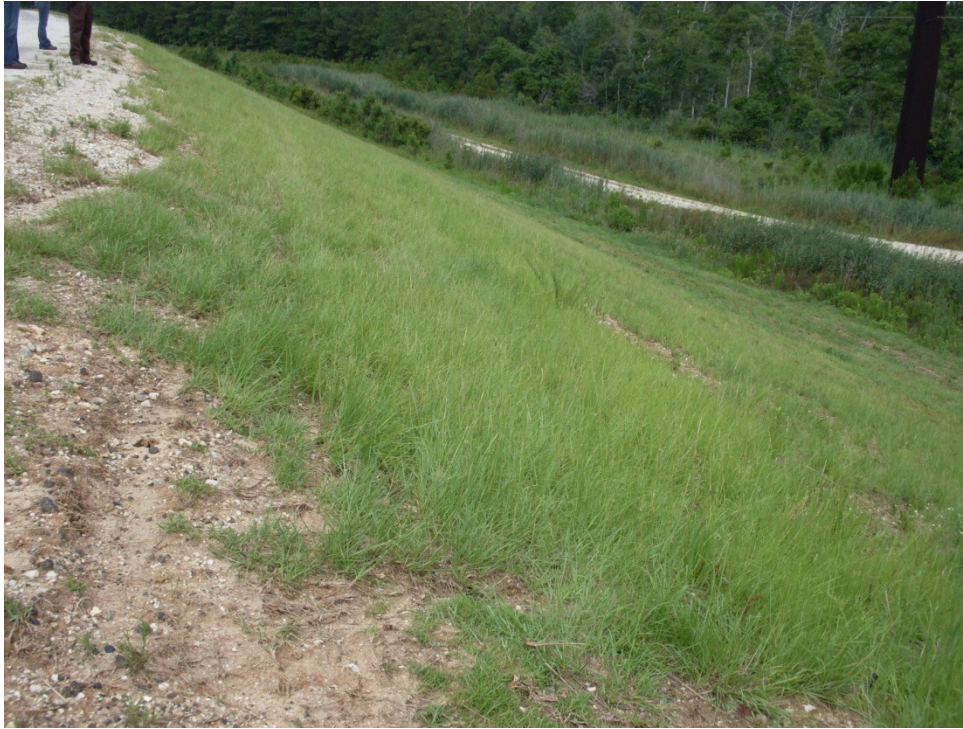
Photo B3-5: Outside Slope of Perimeter Dike of Northwest Side of Unit 3 & 4 Slurry Pond at Repaired Location.

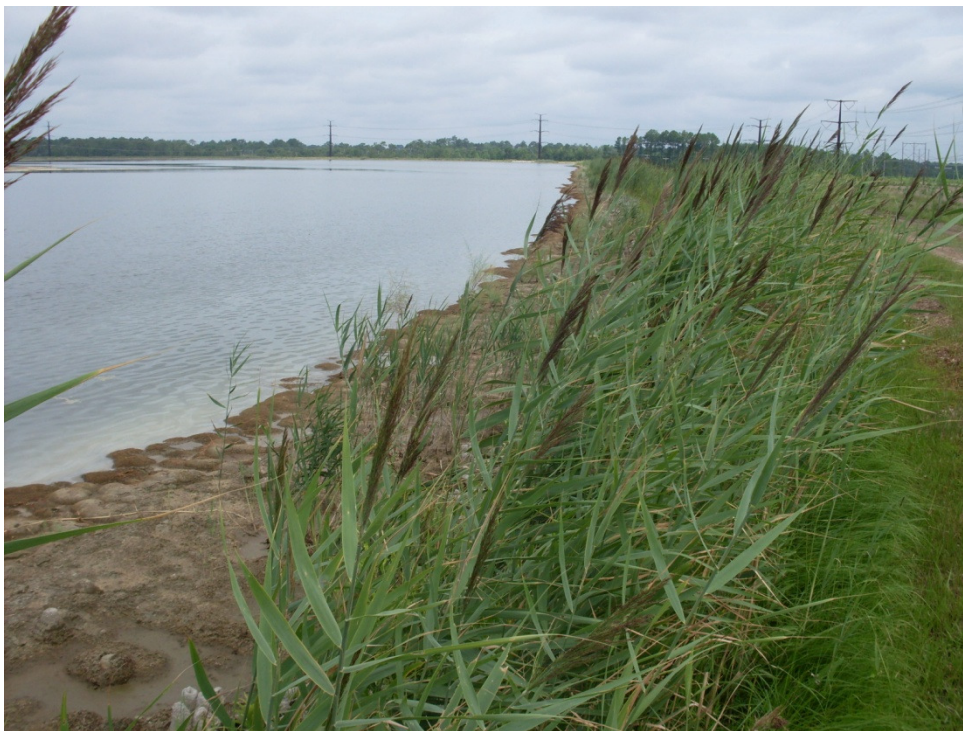
Photo B3-6: Inside Slope of Perimeter Dike at Northeast side of Unit 3 & 4 Slurry Pond – Viewed Northwest.

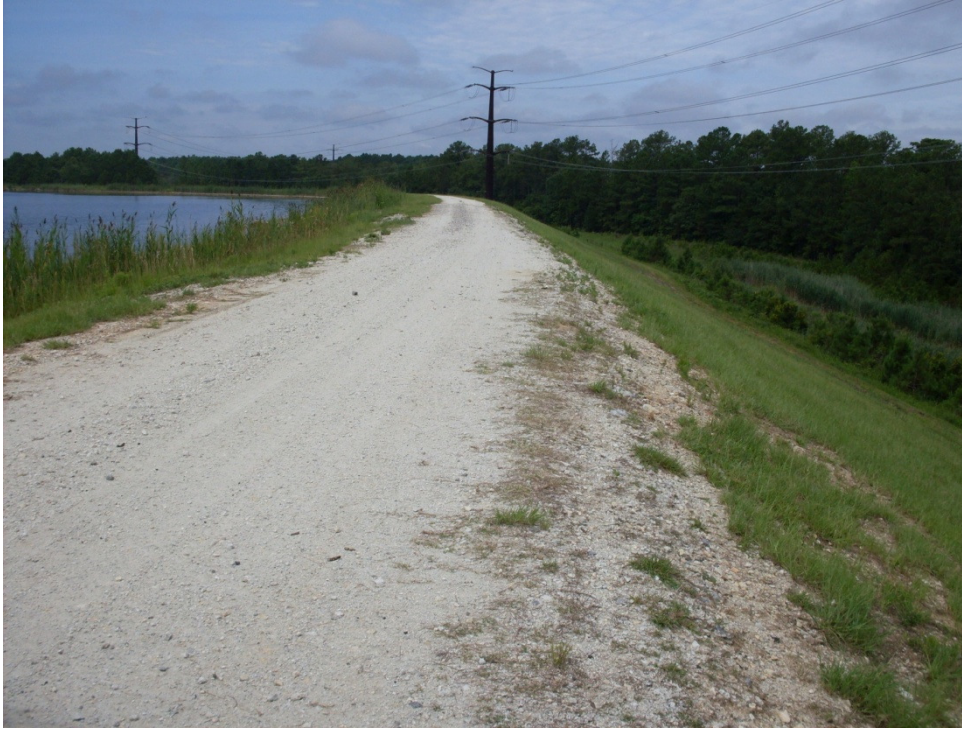
Photo B3-7: Crest of Perimeter Dike at Northwest side of Unit 3 & 4 Slurry Pond at Repaired Location – Viewed East.

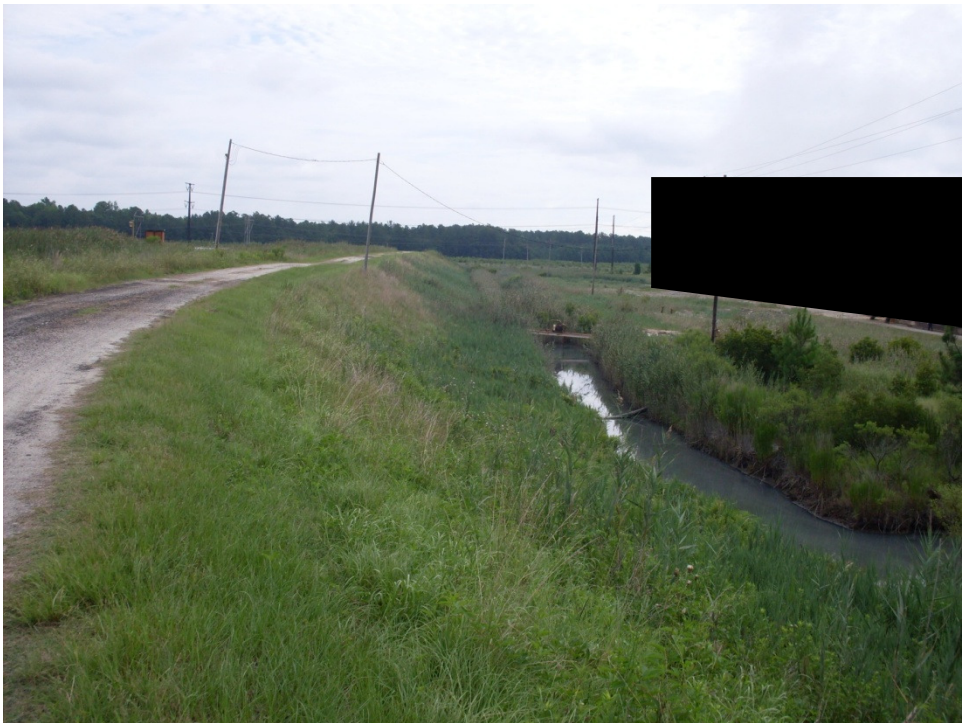
Photo B3-8: Outside Slope of Perimeter Dike Southeast Side of Unit 3 & 4 Slurry Pond – Viewed North.

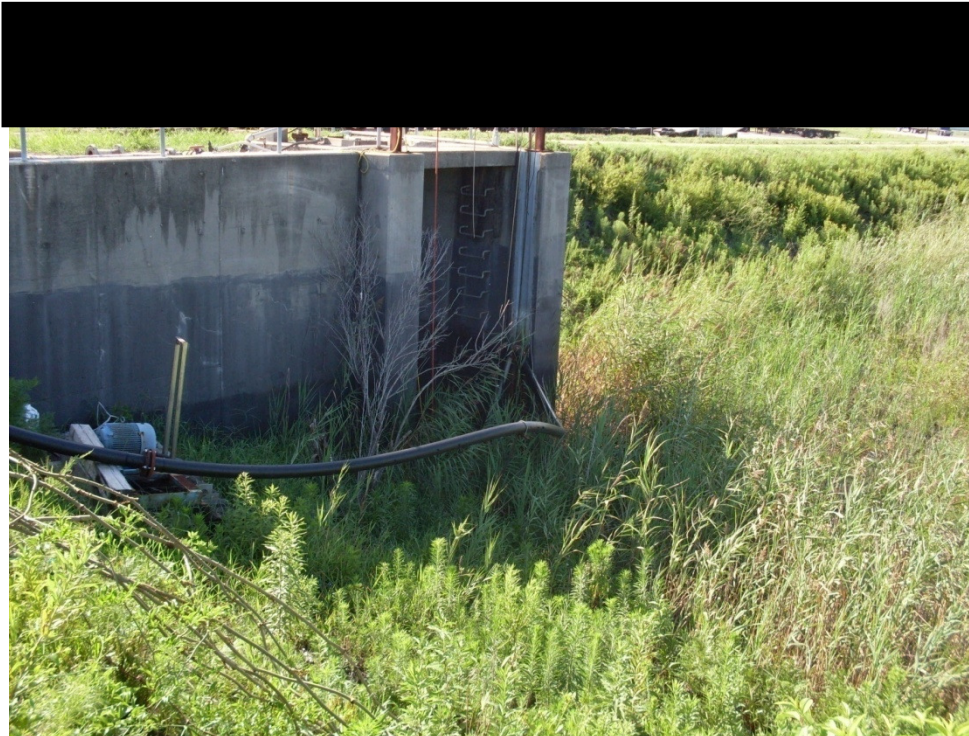
Photo B2-21: View of East Side of Pump Structure of Unit 2 Slurry Pond. (Open Side Formally was Fitted with Wooden Slide Gates to Impound Water in the Pond; Note Normal Water Level Stain on Concrete.)

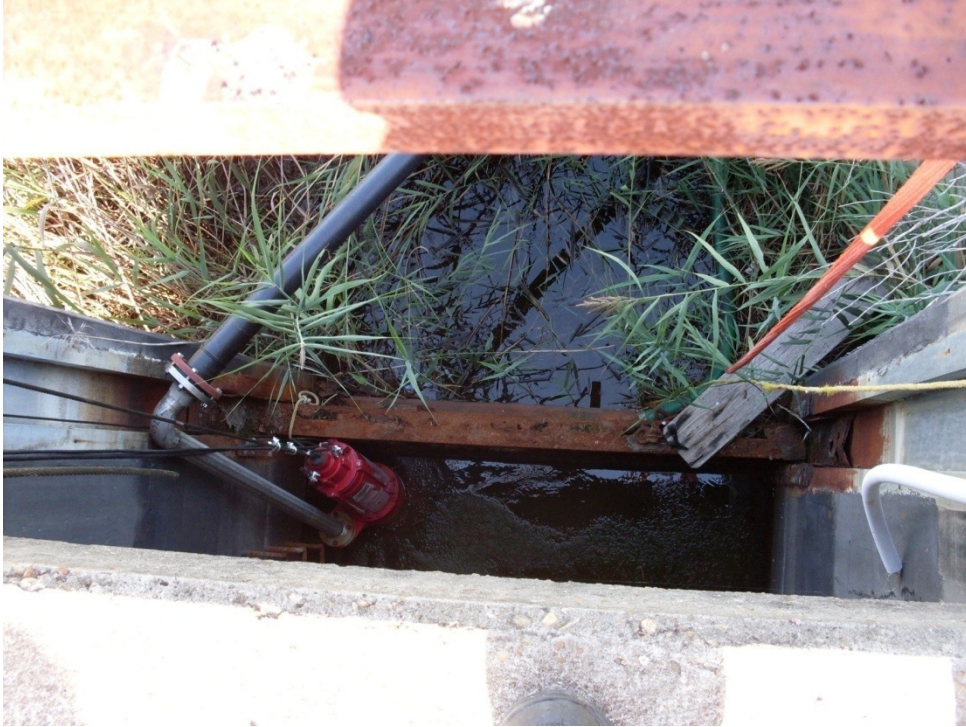
Photo B2-22: View of Pump Placed Inside of Pump Structure of Unit 2 Slurry Pond. (Note Bottom Section of Slide Gate is Raised Slightly.)
